PAINT
AS A VAPOR BARRIER
FOR WALLS
OF OLDER HOMES

RESEARCH
PAPER
FPL 319

FOREST PRODUCTS LABORATORY
FOREST SERVICE
U.S. DEPARTMENT OF AGRICULTURE
MADISON, WIS.

BY
GERALD E. SHERWOOD, Engineer

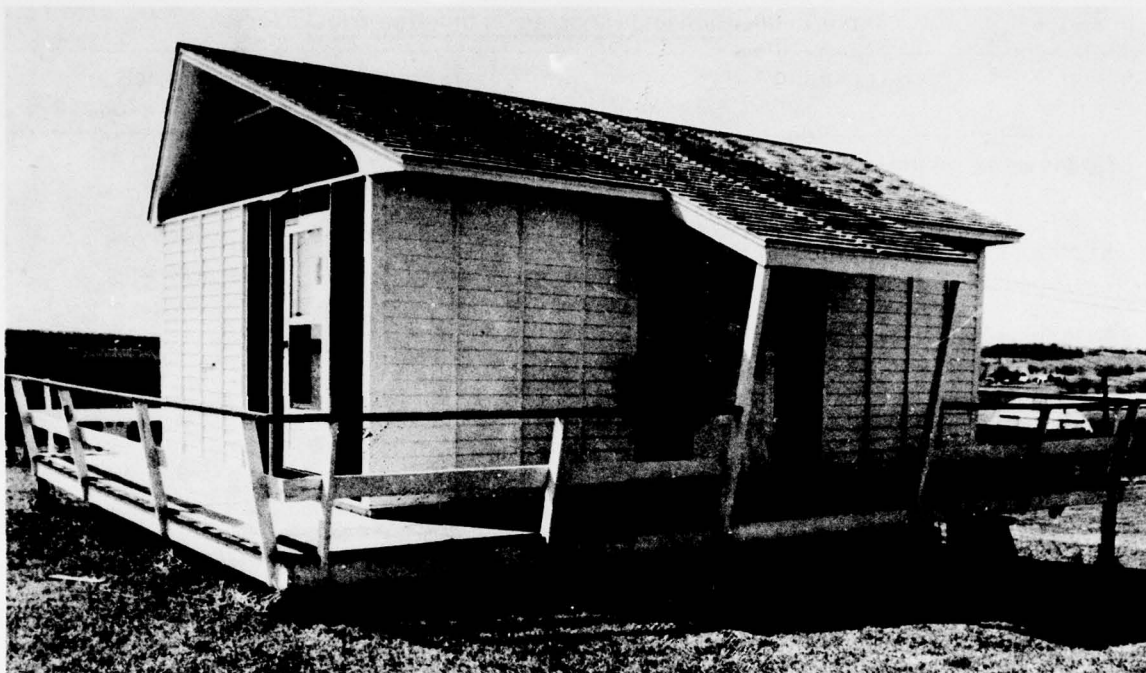
Figure 1. - - The U.S. Forest Products Laboratory test house located on the exposure site near Madison, Wis. (M 144 205-3)

used for the study of moisture distribution in walls of new construction (3) (fig. 1). It was later adapted for the study of moisture in a simulated older home conducted during the winter of 1974-1975. The building had been constructed with conventional floor and roof framing, but vertical support was provided by nominal 4- by 4-inch posts at 8-foot spacing to permit the use of seven 8- by 8-foot removable wall panels. Each of the seven wall panels was divided into four spaces with nominal 2- by 4-inch studs, resulting in 28 test spaces (fig. 2, table 1). Only five of the wall panels were used in the tests presented here. A nominal 1- by 6-inch board coated with aluminum paint was placed adjacent to each stud and extended to the outside to prevent moisture transfer between spaces and the sheathing or siding covering each space.

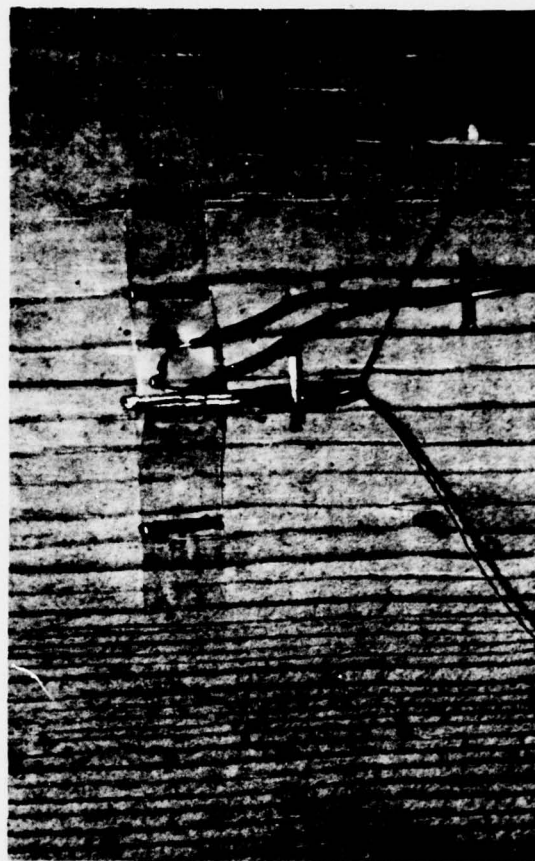
Figure 5. - - Moisture probe and thermocouple attached to interior surface of sheathing board.
(M 144 309)

The moisture content (MC) of small wood sensors was measured at three locations in each space (fig. 3). Actual installations are shown in figures 4, 5, and 6. A total of 60 locations were measured for wood MC with small wood-type sensors but MC of actual components was not determined. The relative humidity within the rooms was monitored using a sling psychrometer.

changes of 10° F or more. Inside room temperature was used for correcting the moisture probes located immediately adjacent to the interior wall lining. Outside air temperature was used to correct the probes immediately beneath the siding. For moisture probes within the wall between the insulation and sheathing, actual thermocouple measurements were made for each probe. Placement of a probe and its associated thermocouple for temperature is shown in figure 5.
